TEST REPORT

OF ALARM INTRUSION SYSTEMS COMPONENT TESTS

| Product: | Outdoor Self Powered Sirens | |
| Type : | IRIS BASIC | |

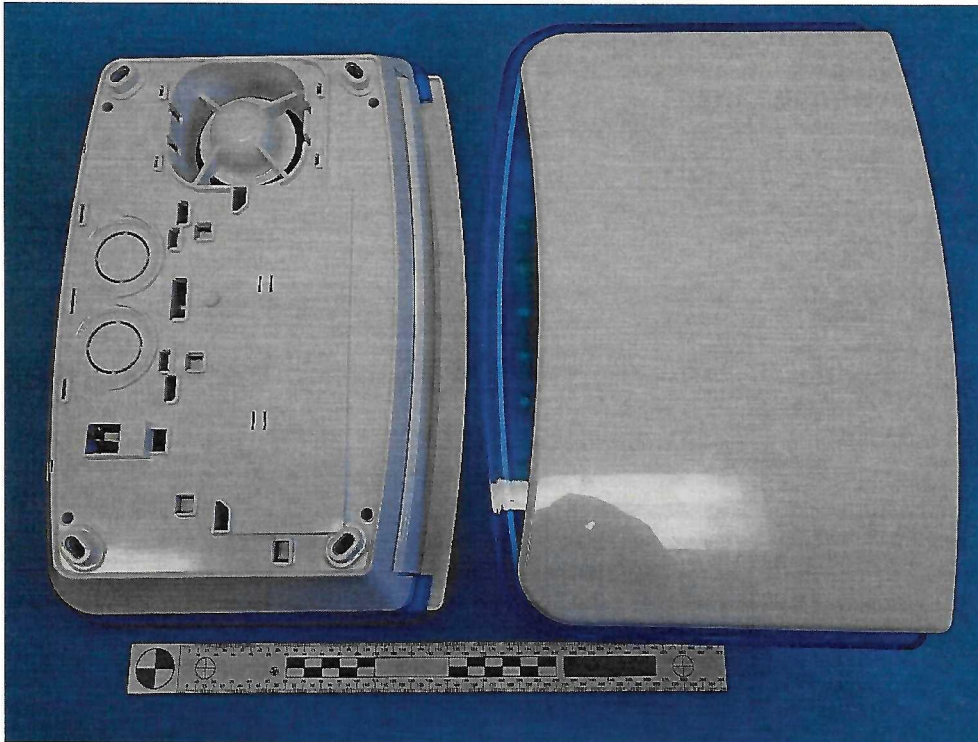
Annex No.: 1a

Outdoor Self Powered Sirens IRIS BASIC

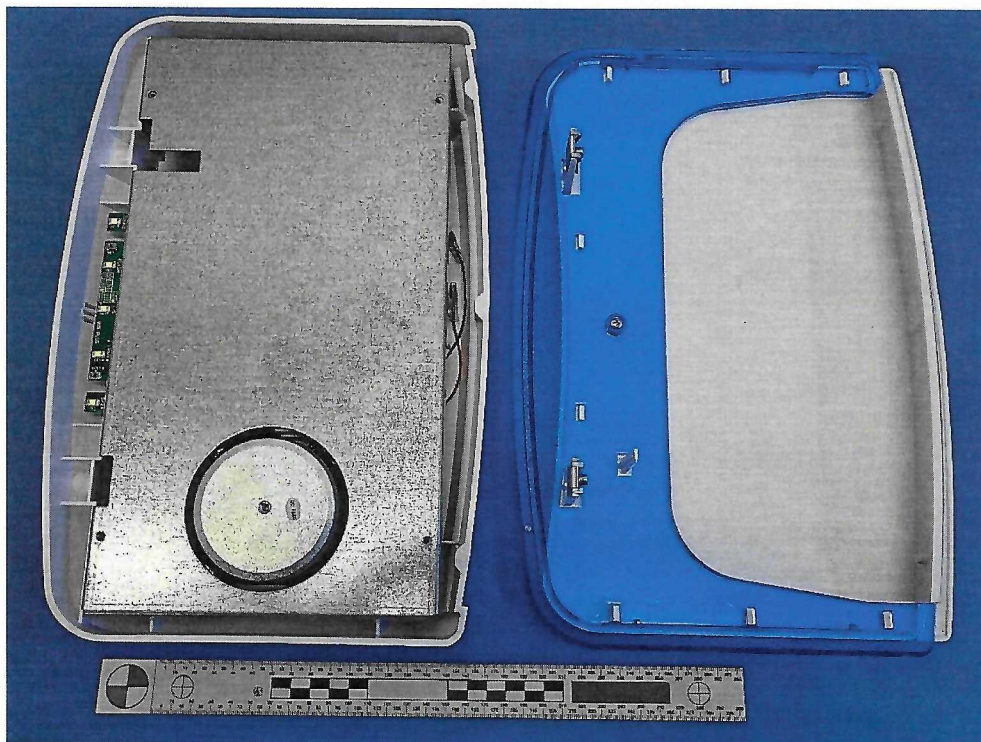
Outdoor Self Powered Sirens IRIS BASIC

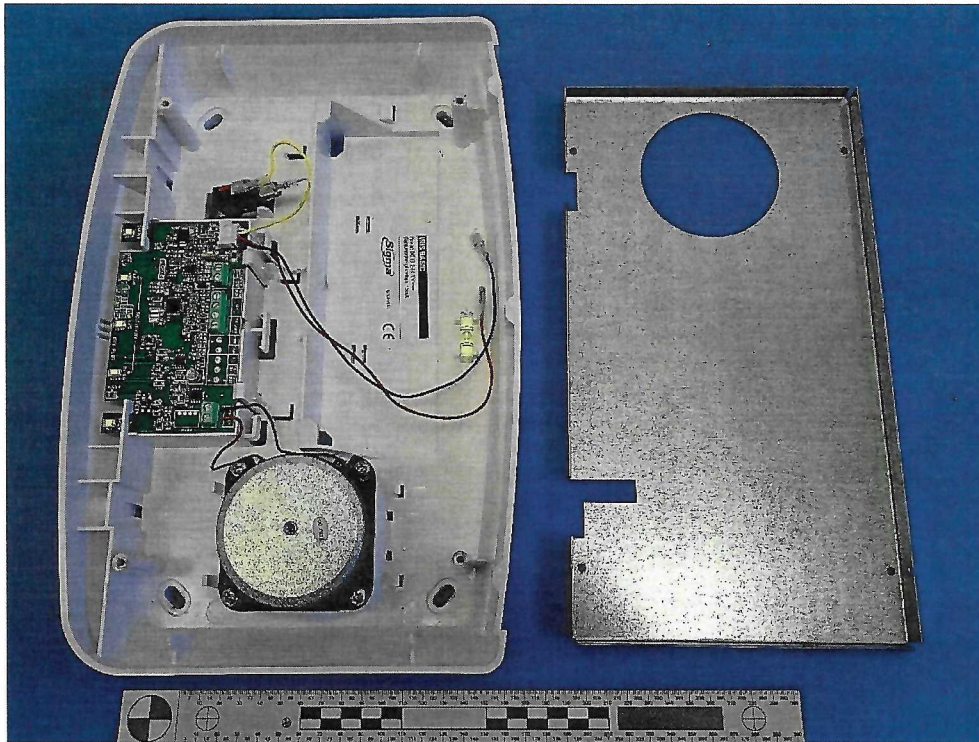
Outdoor Self Powered Sirens IRIS BASIC

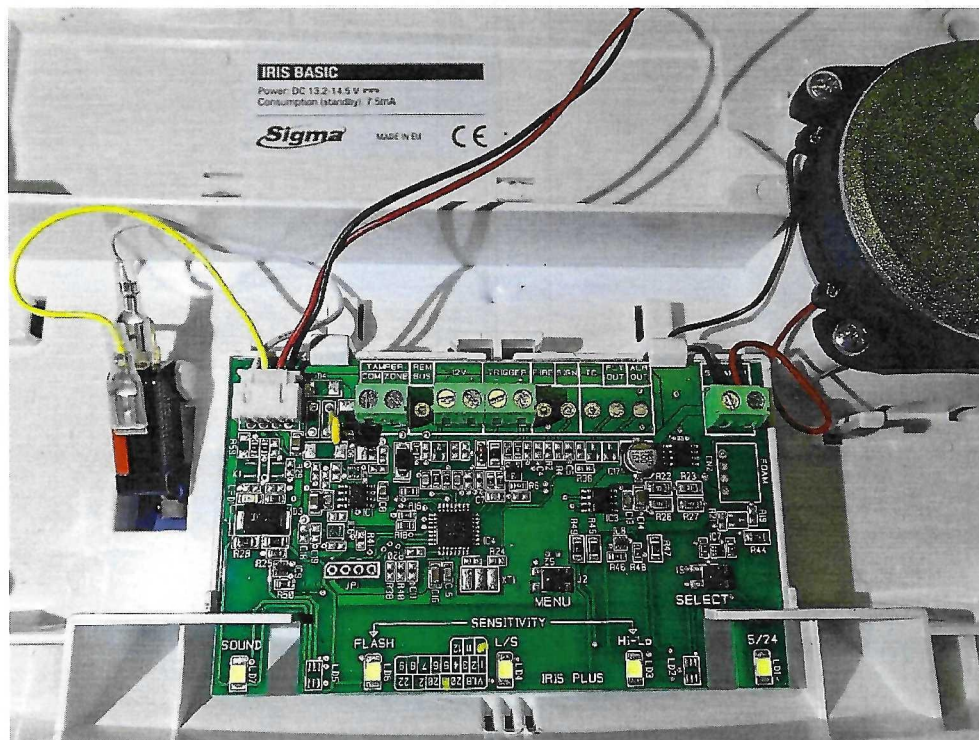
Outdoor Self Powered Sirens IRIS BASIC

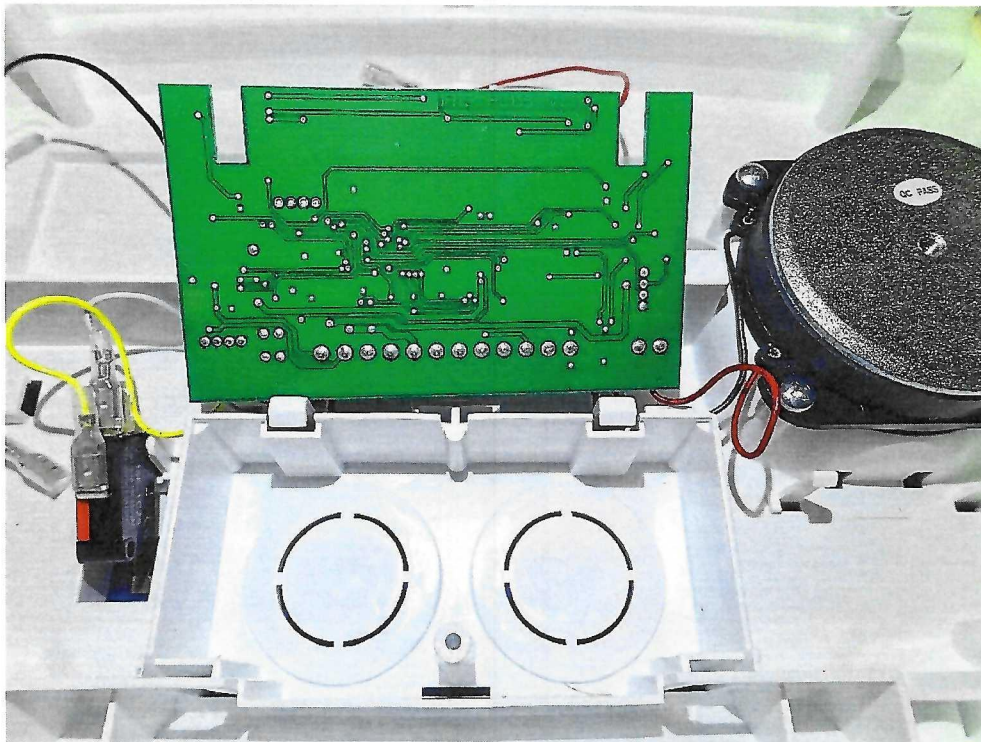
Annex No.: 1c

Outdoor Self Powered Sirens IRIS BASIC

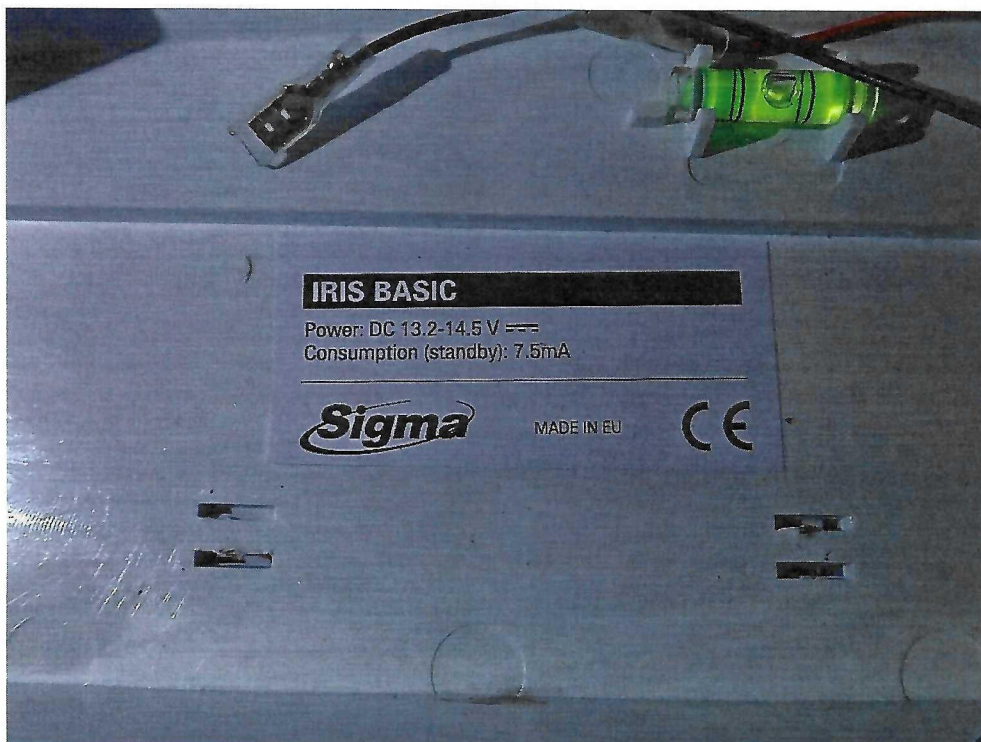
Outdoor Self Powered Sirens IRIS BASIC
